Marine Safety Office
Charleston, SC
Photograph

MV Case#: MV00004649

Location: Cummins Engine Company, Charleston, SC

Enclosure (7)

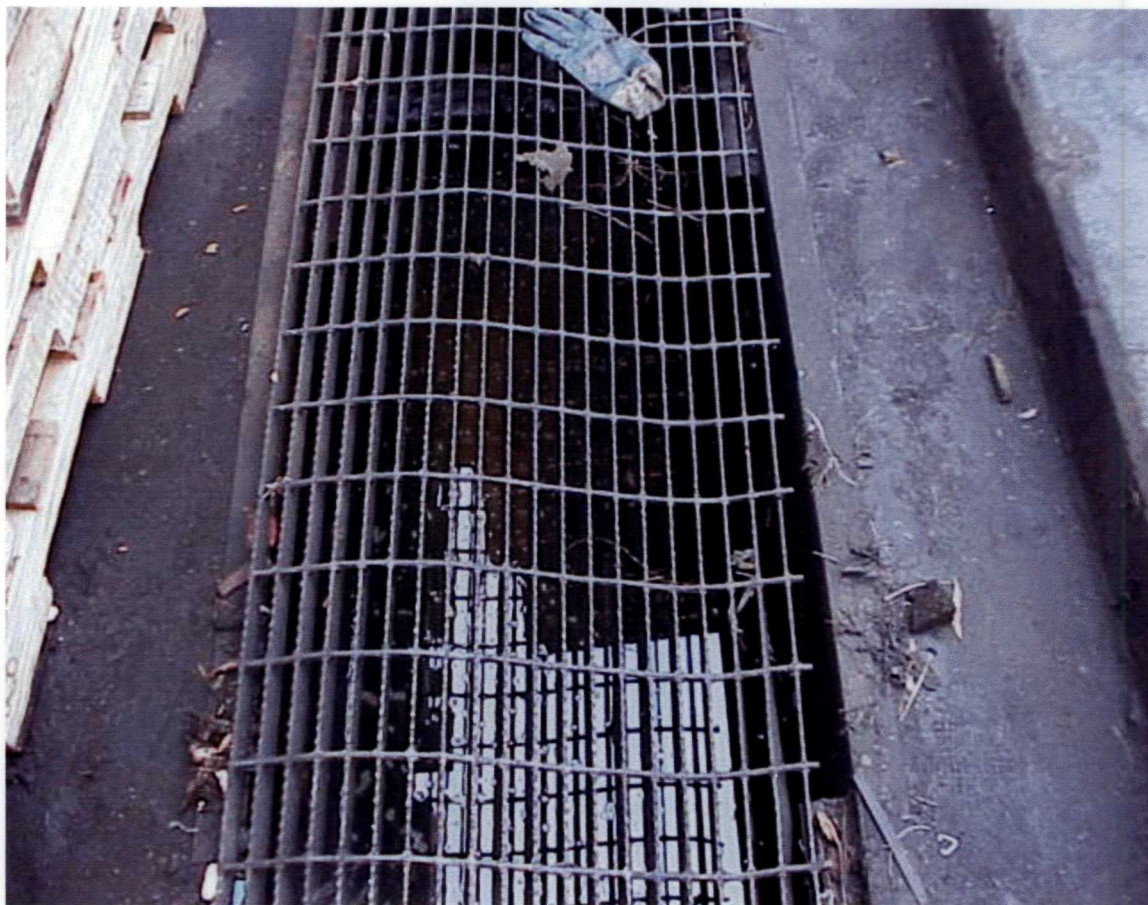
Photo Number: 7

Photo Description: Picture of drain, oil visible in drain.

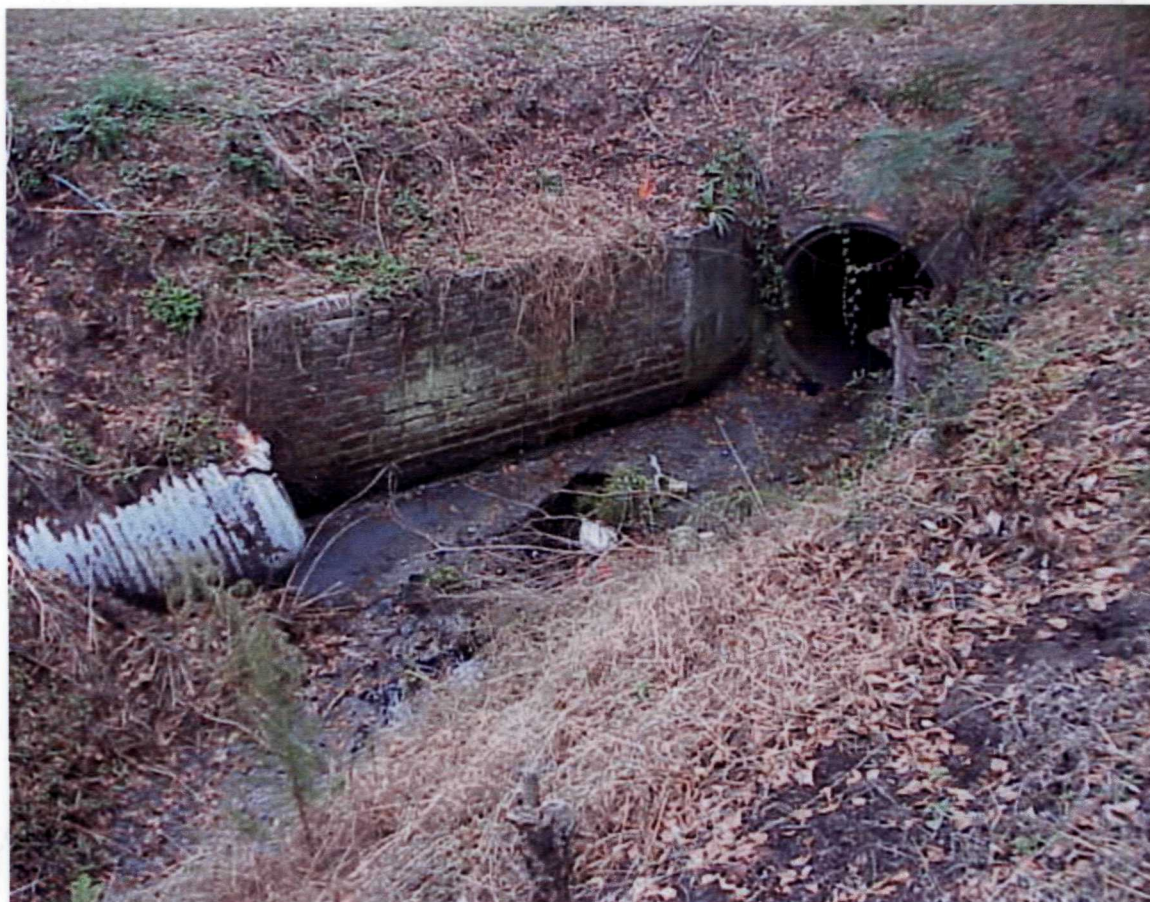
Photo Number: 3

Photo Description: Stormwater ditch adjacent to Cummins property, located above previous pictures. Corrugated pipe visible on left hand side leads to stormwater manhole located on Cummins Property. Dark oil visible in center of picture.

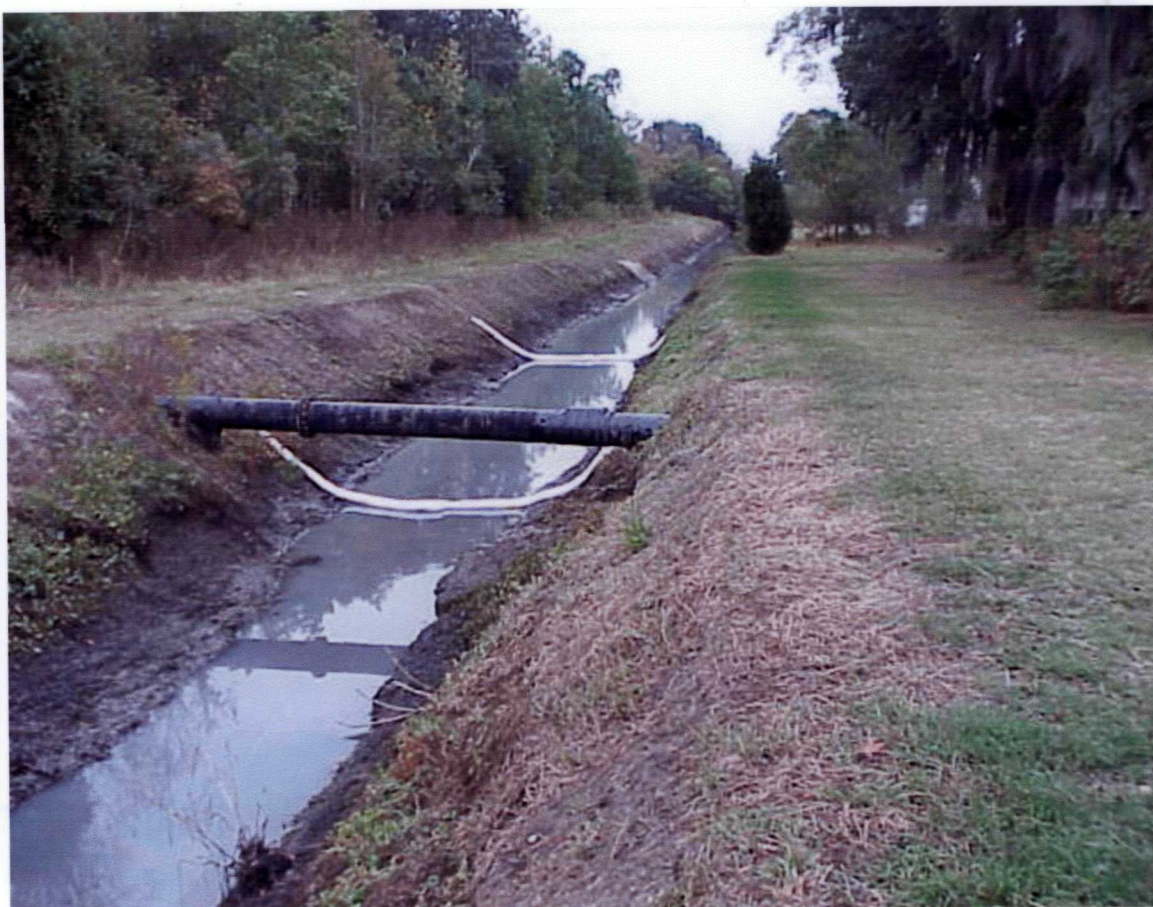
Photo Number: 2

Photo Description: Stormwater ditch adjacent to Cummins property, two sections of adsorbent boom are visible in center of picture.

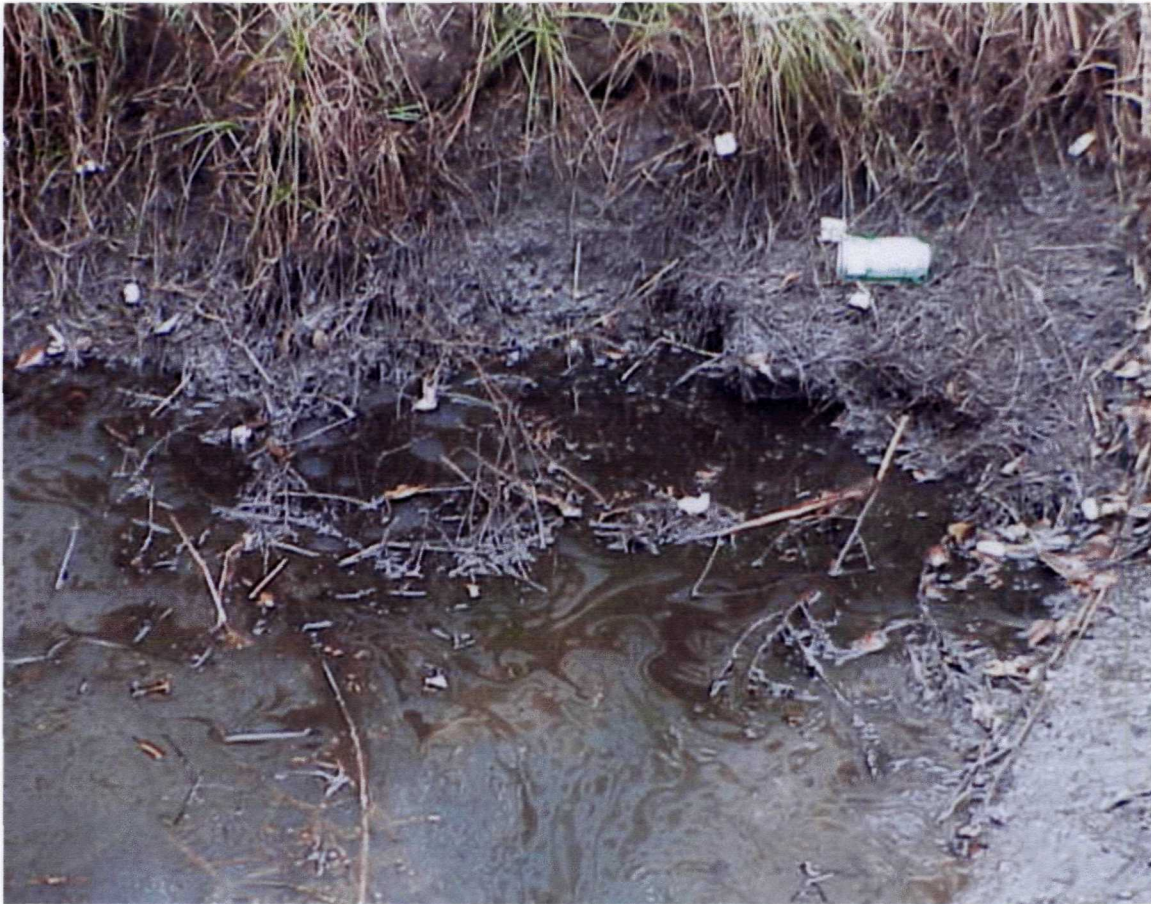
Photo Number: 4

Photo Description: Stormwater ditch adjacent to Cummins property, close-up of oil from picture 3.

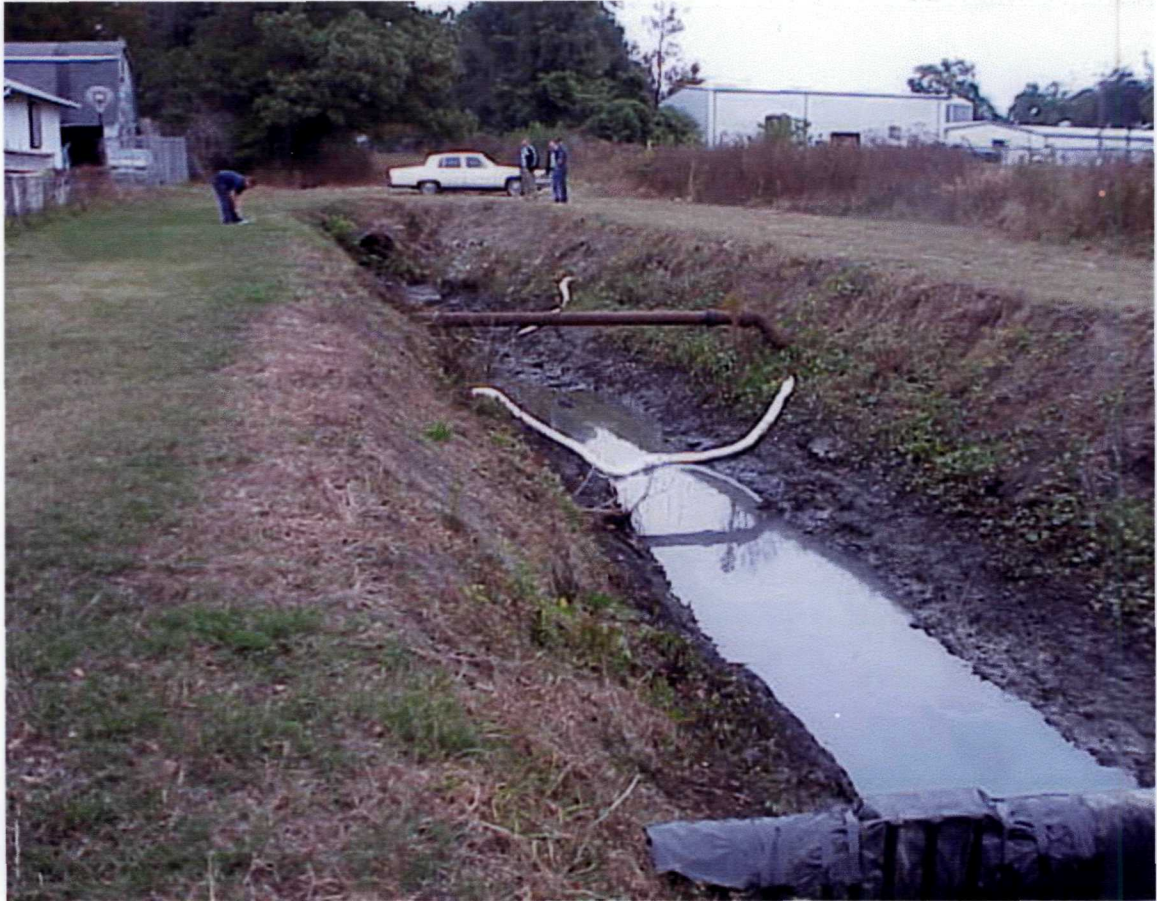
Photo Number: 1

Photo Description: Stormwater ditch adjacent to Cummins property, two sections of adsorbent boom are visible in center of picture.

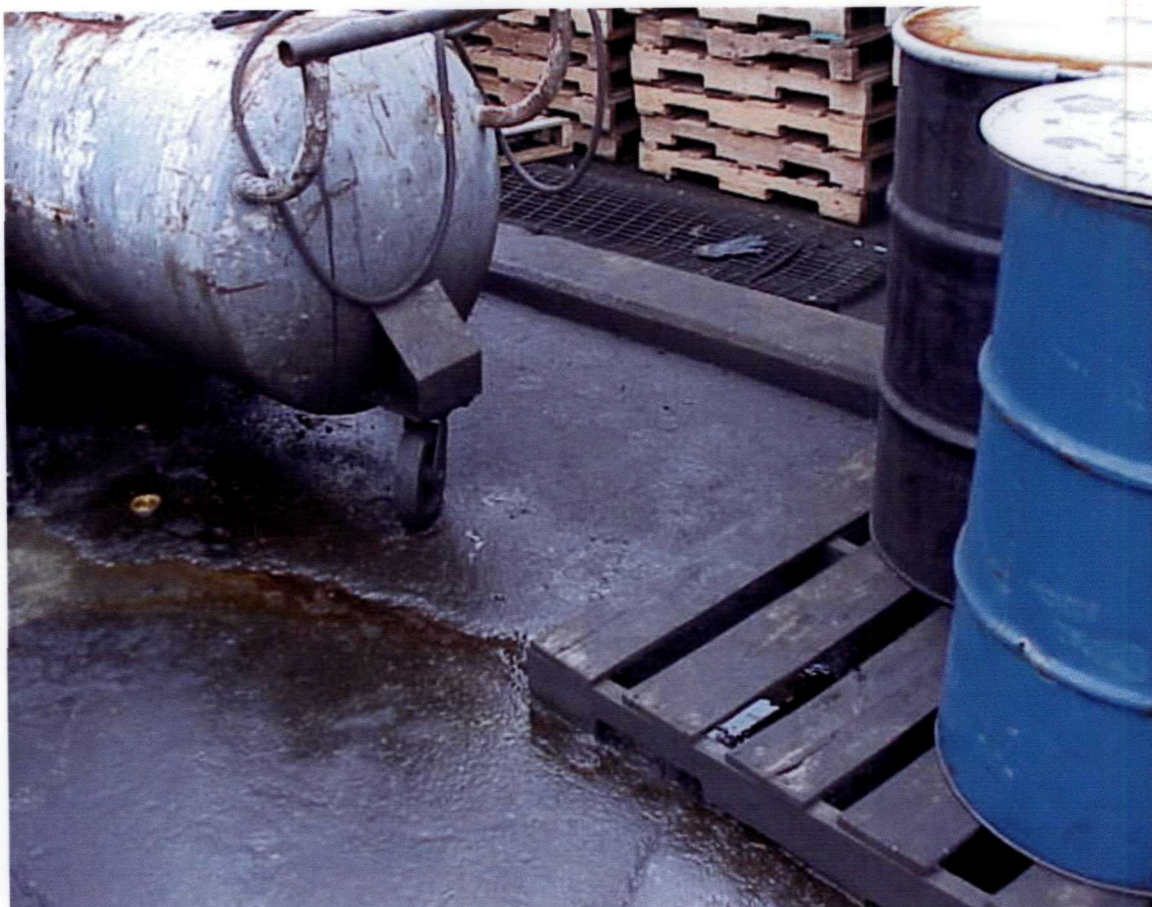
Photo Number: 6

Photo Description: Close-up of drain.

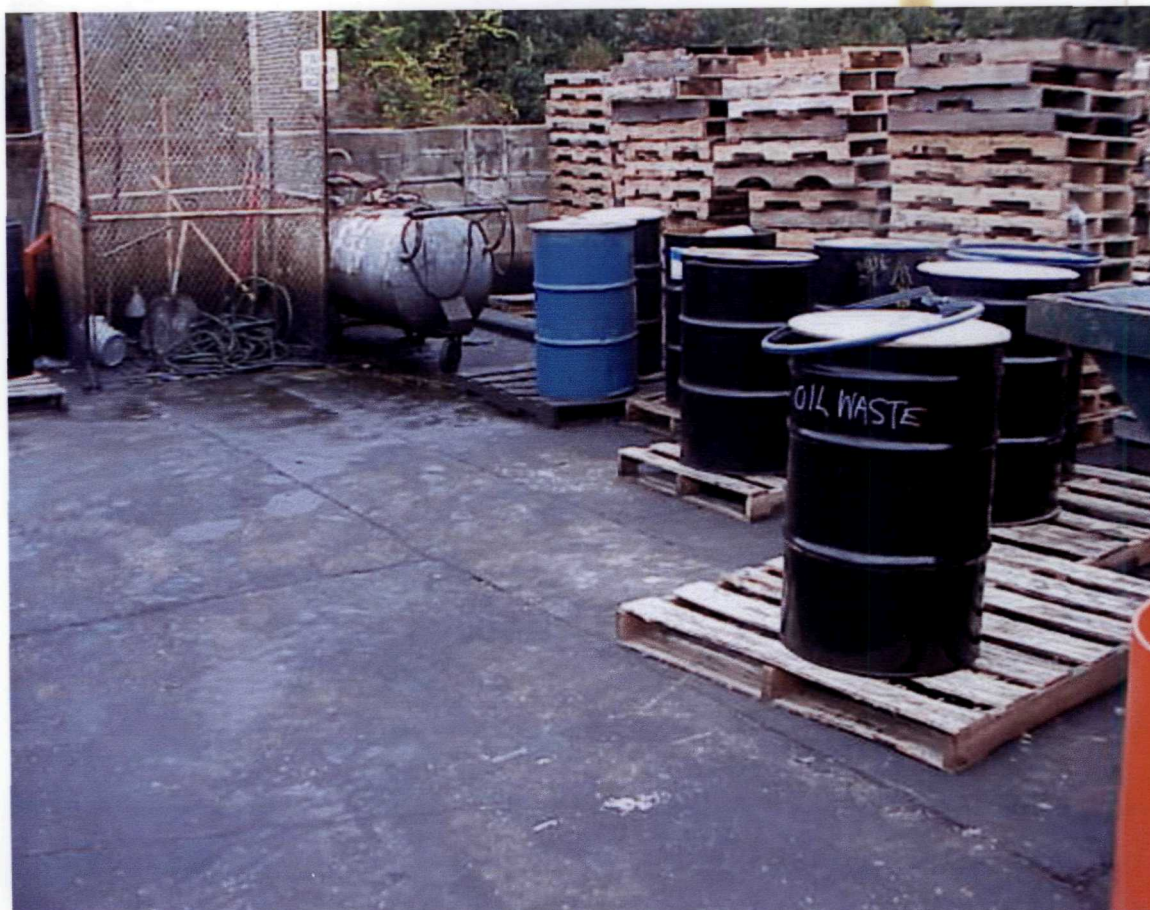
Photo Number: 5

Photo Description: Storage area behind Cummins wastewater treatment building.
